Alpine Butterfly Loop Damage and Its Impact on Rope Access Technician Safety: Insights from Testing

Ondřej Belica¹

¹ CRAA – Institute of Occupational Safety at Heights; obelica@lezectvi.cz

Review Article

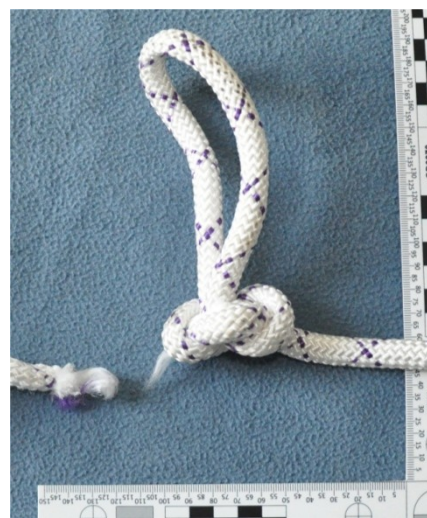
Figure 4: The undamaged loop after Test 0-a [2, p. 6]

The strength of an undamaged alpine butterfly loaded via the loop was 20 ± 1.7 kN. In all cases, failure occurred within the knot itself rather than in the knot loop.

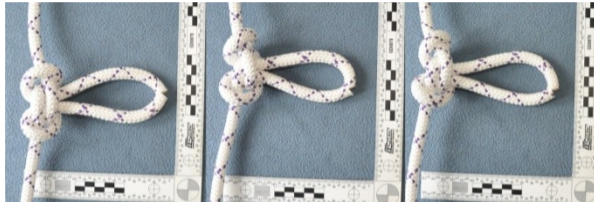
During the preparation of the first test specimens, a depth stop was not used, unlike in the subsequent specimens, and the depth of the cut – approximately half of the rope diameter – was only estimated.

Figure 5: Test specimens prepared for Test 1 [2, p. 7]

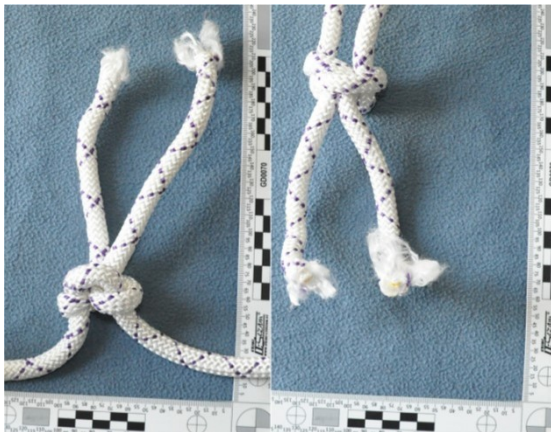
The very first test specimen (1-a) exhibited the deepest cut of all specimens, which was evident visually and was also reflected in the lowest measured strength during testing. The average strength of alpine butterfly knots damaged on the outer side of the apex of the loop was 16 ± 3.6 kN. In tests 1-a and 1-c, failure occurred in the loop at the location of the damage, whereas in test 1-b the knot itself failed, regardless of the loop damage. It should be reiterated that the cuts damaging the rope in these specimens were deeper than in all other test specimens.

Figure 6: Specimen 1-a after the test [2, p. 7]

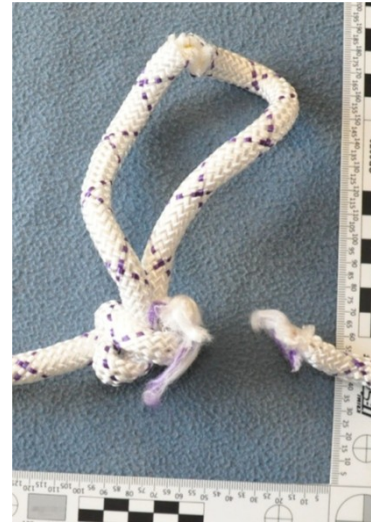
Failure of the rope at the location of the damage on the inner side of the apex of the knot occurred only in test 2-b, at a force of 18.62 kN. In the remaining two cases (2-a and 2-c), failure occurred in the knot itself, regardless of the damage to the rope within the loop. Alpine butterfly knots with damage on the inner side of the loop

exhibited an average strength of 19.9 ± 0.85 kN.

Figure 7: Specimen 2-c after the test [2, p. 8]

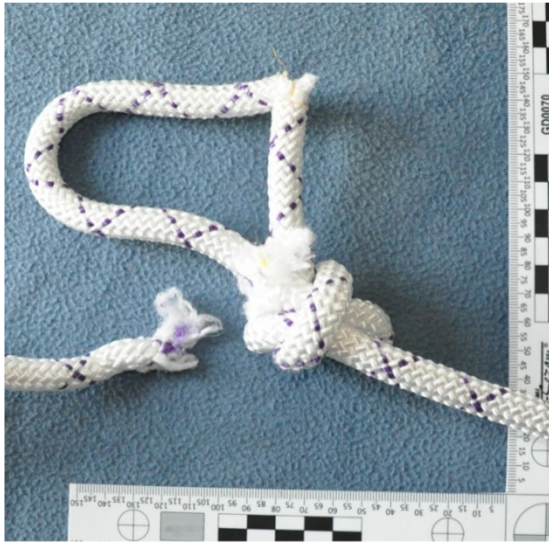
From a load-distribution perspective, configurations in which the damage is not located at the apex of the loop appear to be safer, as two sections of the loop are loaded evenly from the undamaged apex, one of which remains free of damage. In all three tests conducted within Test 3, failure occurred in the knot, while the damage to the loop had no effect on the overall strength of the system. The force required to break an alpine butterfly knot with loop damage located outside the apex was 20.2 ± 0.65 kN.

Figure 8: Specimen 3-c after the test [2, p. 9]

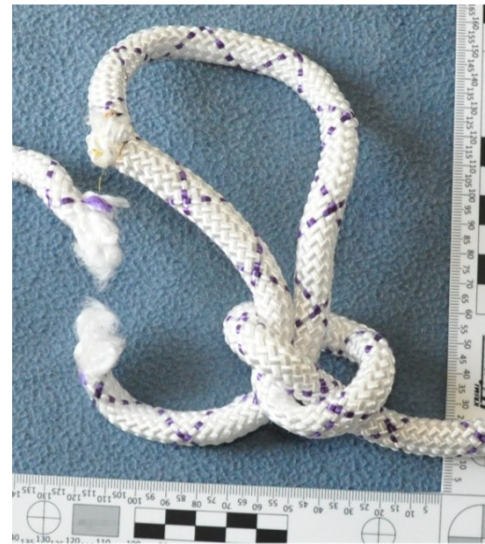
Damage to the outer side of the loop in Test 5 did not affect the strength of the chain; in all three tests, the knot itself failed. Failure occurred at a force of 21 ± 1.1 kN.

Figure 9: Specimen 5-b after test [2, p. 10]

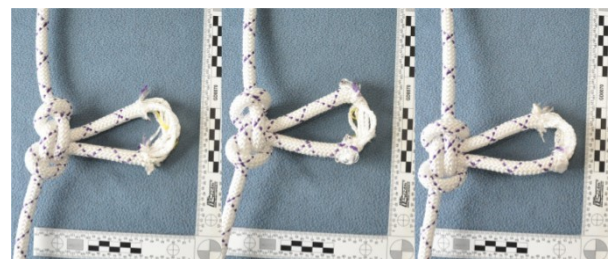
Removing the sheath from the rope at the apex of the loop would theoretically reduce the loop's strength by 47% compared to its original strength. Nevertheless, in tests 7-a and 7-b, failure occurred in the knot (the damaged loop had no effect on the overall chain strength), and in test 7-c, the rope failed in the testing machine's grip (i.e., completely outside the knot).

Figure 10: Specimens prepared for test 7 [2, p. 12]

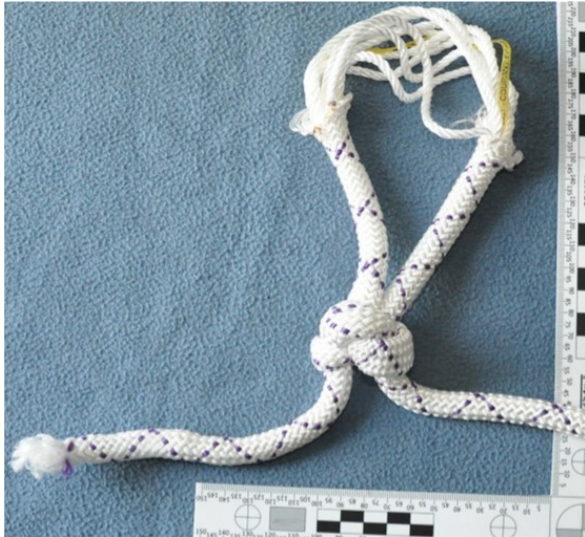
The knots failed at a force of 20 ± 0.8 kN. It is worth mentioning that during sheath removal for specimen 7-a, several yarns in one of the core strands were unintentionally cut.

Figure 11: Specimen 7-c after the test
[2, p. 12]

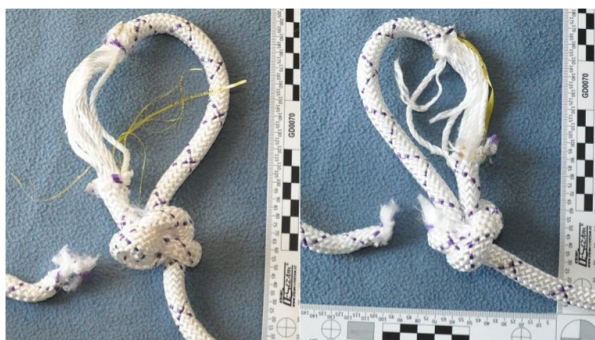
When testing alpine butterfly loops with the sheath removed in the upper part of the loop, the knot always failed (the removed sheath had no effect on the loop's strength). Interestingly, during tests 8-a and 8-c, the rope marking tape was partially damaged (but did not break), and during test 8-b, several yarns in two strands of the core were broken. The knots themselves failed at a load of 20.78 ± 0.02 kN.

Figure 12: Specimens 8-a (left) and 8-b (right) after the tests
[2, p. 13]

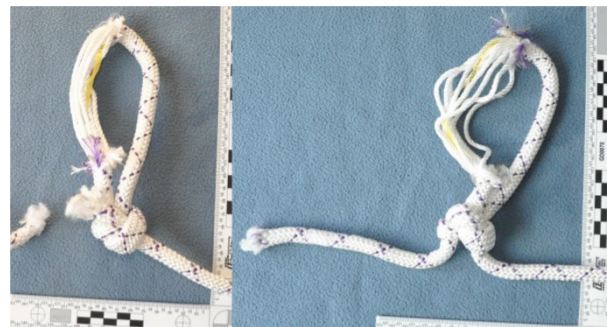
While testing alpine butterflies with the sheath removed from the upper part of the loop always resulted in the failure of the tested loop, in contrast, in the case of loops with the sheath removed from the lower part, two tests (9-a and 9-b) failed at the rope gripping system of the testing machine, and one test failed at the loop itself. In none of these cases did the removal of the sheath affect the overall strength of the chain, which was 20.1 ± 0.97 kN.

Figure 13: Specimens 9-b (left) and 9-c (right) after the tests
[2, p. 14]

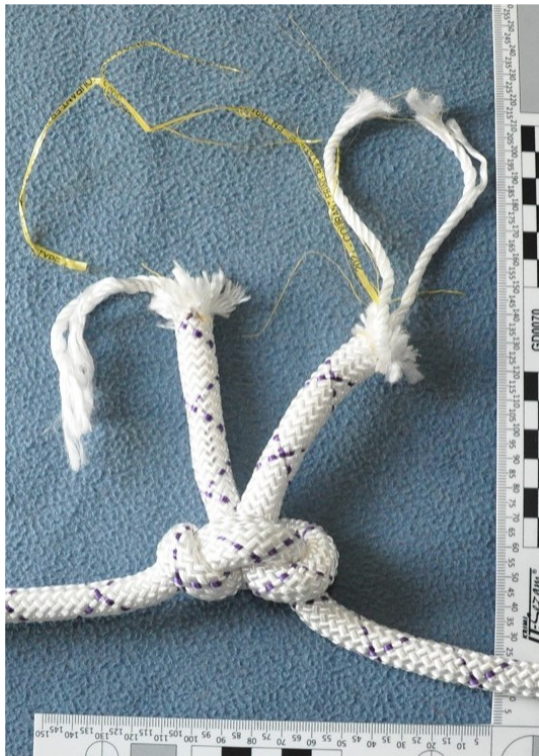
The last test examined the worst-case damage scenario, i.e., a rope stripped of its sheath and most of its core. Only two strands and the rope's marking tape (internal marking) remained at the apex of the loop. In this test, unlike all others, the loop failed at the damaged site in every trial, at a force of 9.4 ± 0.17 kN. Interestingly, the marking tape itself did not break until a force of about 2 kN was applied (which does not imply that the tape alone can sustain 2 kN, but rather that the two remaining strands provided sufficient support for the tape to withstand forces up to this level).

Figure 14: Specimen 10-b after the test [2, p. 14]

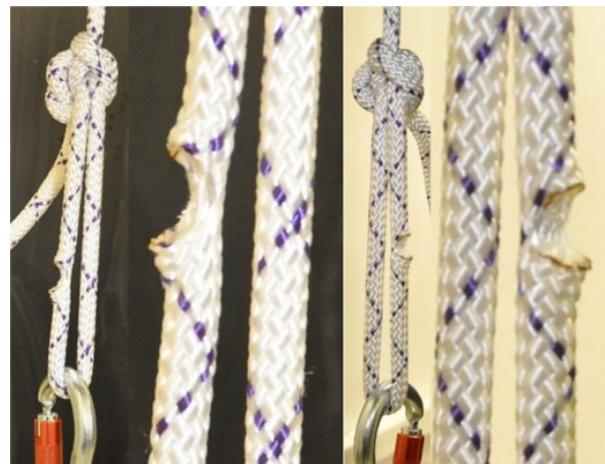
Figure 15: Specimens 5-b (left) and 3-b (right) during the tests [2, p. 16]

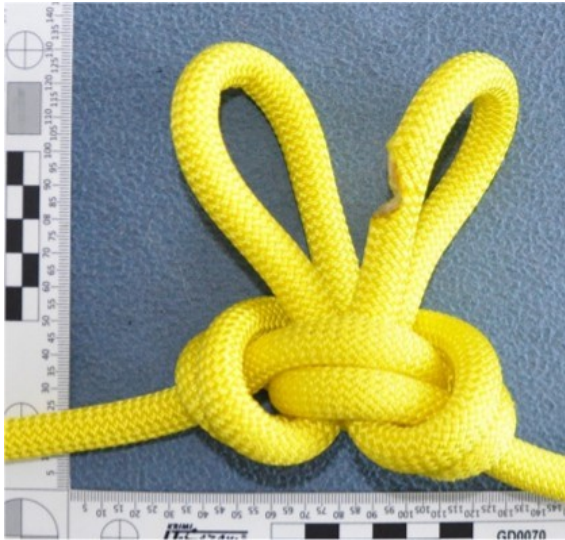
Figure 16: The double alpine butterfly is safe enough clipping cowstail even if one of the loops is damaged [2, p. 17]

Even so, clipping to a damaged loop of the alpine butterfly must not compromise the user's safety. Not only for peace of mind but primarily to maximize safety, it is advisable to use a double alpine butterfly and clip to both of its loops. Such an arrangement cannot endanger the rope access technician and, importantly, speeds up passing the knot.
